CASE STUDY

VN-200 AND VN-210 AERIAL TRIANGULATION REPORT SUMMARY

VN-200 and 210 GNSS-Aided
Inertial Navigation Systems

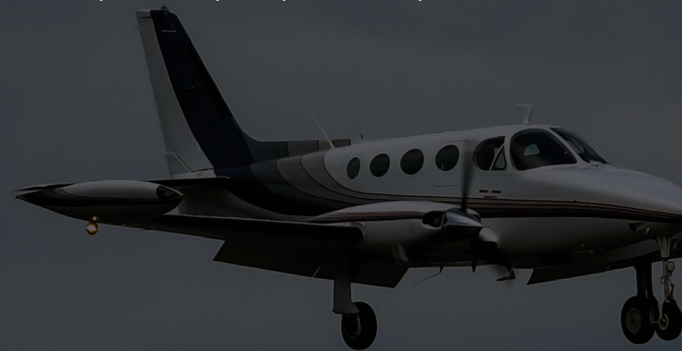
The aircraft used in this test was a Cessna 310, operated by Williams Aerial of South Bend, Indiana. Two VN-200 and two VN-210 INS units were installed to a precision milled aluminum plate, and each INS unit was connected to a Tallysman TW2410 GNSS antenna. The setup also included a calibrated Leica RC-30 aerial mapping camera, which is able to determine the position of image points in the focal plane to an accuracy of 10 micrometers. The Leica RC-30 features a 6 inch (~15 cm) focal length, wherein a single ray is capable of being measured with an uncertainty of less than 0.004 degrees. Hundreds of these rays were measured over multiple images from the flight and combined with ground control points known to 2 cm to determine the attitude of each photograph.
